This approach helps uncover reliability problems obscured by the volume of plant work requests.

Progress Energy's Harris nuclear power plant in New Hill, NC, is taking a proactive approach to identify and improve equipment performance. Power plants such as Harris have more than 100,000 components. Personnel perform thousands of maintenance activities annually.

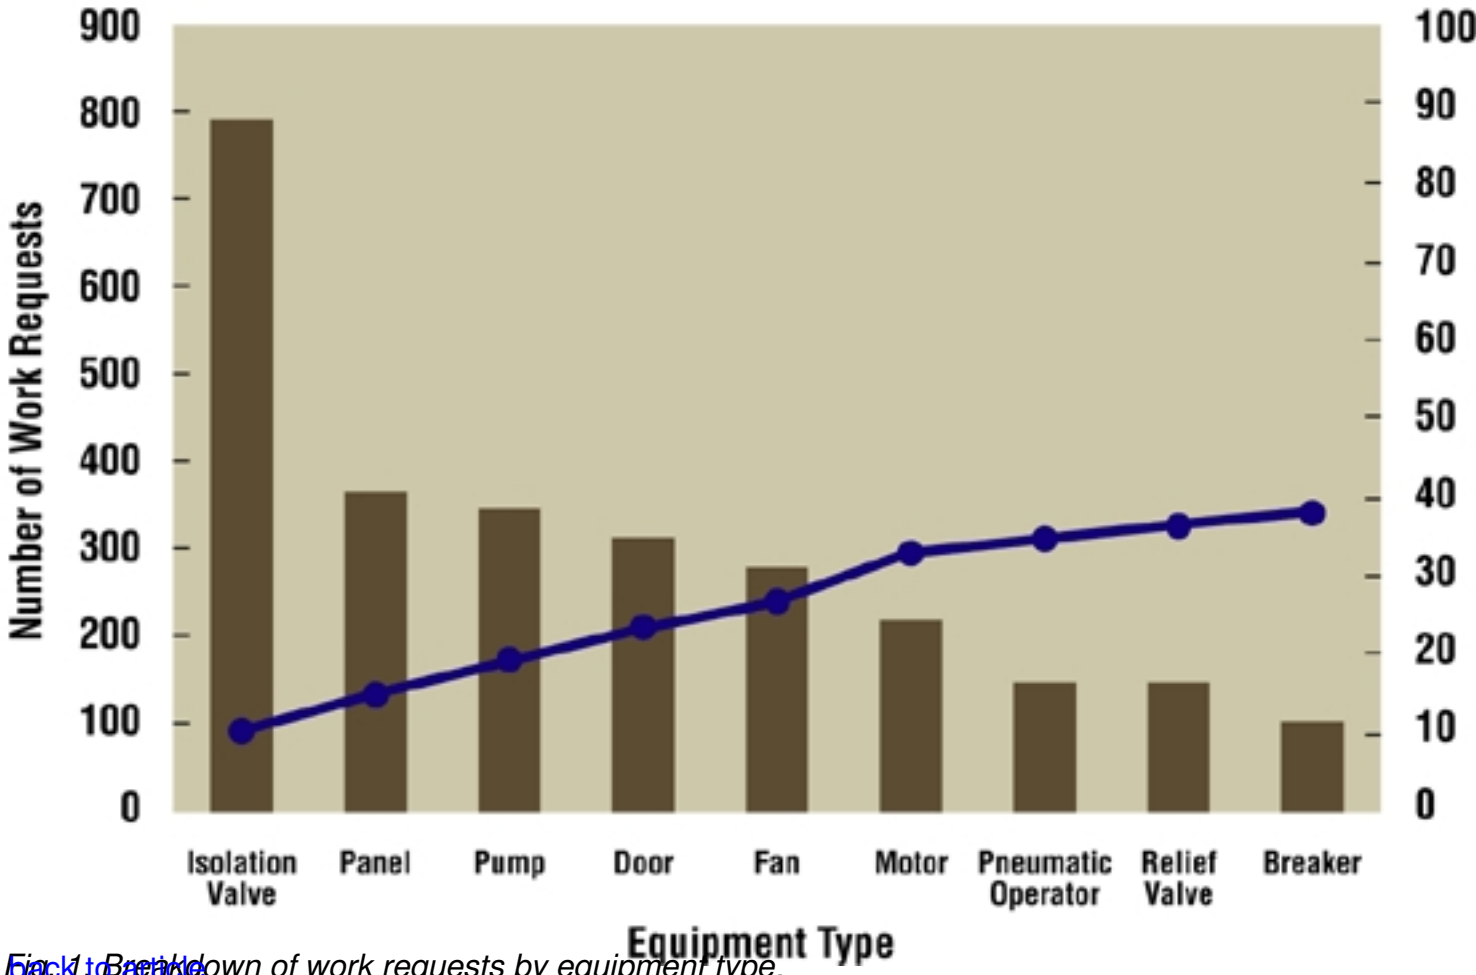
FAN RELIABILITY 2001-2003

Work requests from 2001-2003 were reviewed at Harris and sorted by equipment type. The counts for equipment that comprised 40 percent of all maintenance performed at the plant over the 3-year period are shown in Fig. 1 .

There are several hundred equipment types in use at the plant. The benefit of this systematic breakdown is a focused review of a limited number of components. In this case, nine equipment types were involved: Isolation valve, panel, pump, door, fan, motor, pneumatic operator, relief valve, and breaker.

Fig. 1 Breakdown of work requests by equipment type.

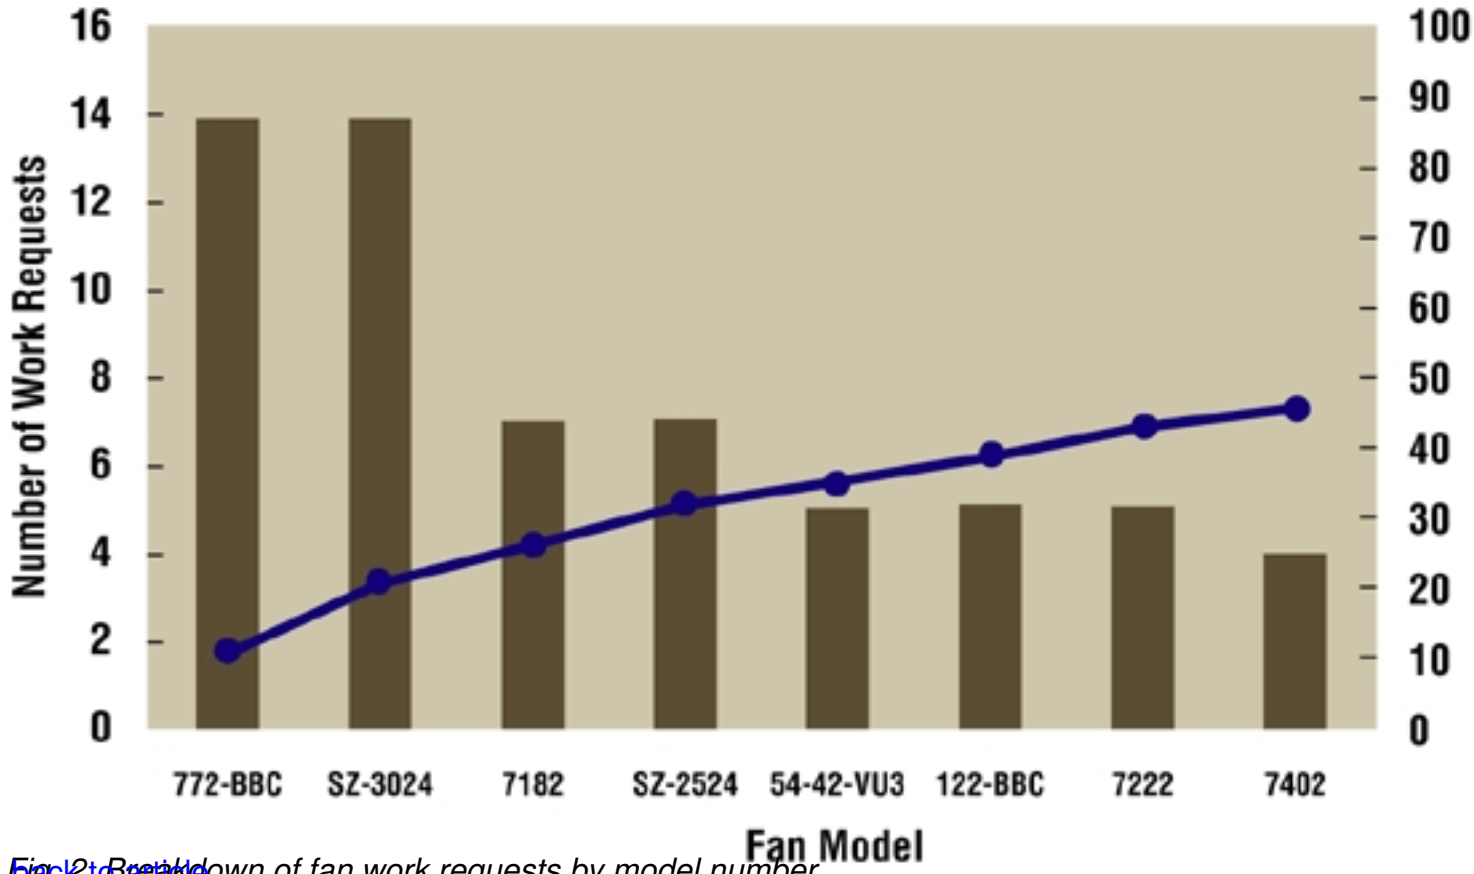
FAN RELIABILITY 2001-2003

Of the 58 fan models at Harris, eight models required nearly 50 percent of the fan maintenance work during the 2001-2003 period. Again this systematic breakdown permits a focused review of a manageable number of fan applications.

Fig. 2. Breakdown of fan work requests by model number.

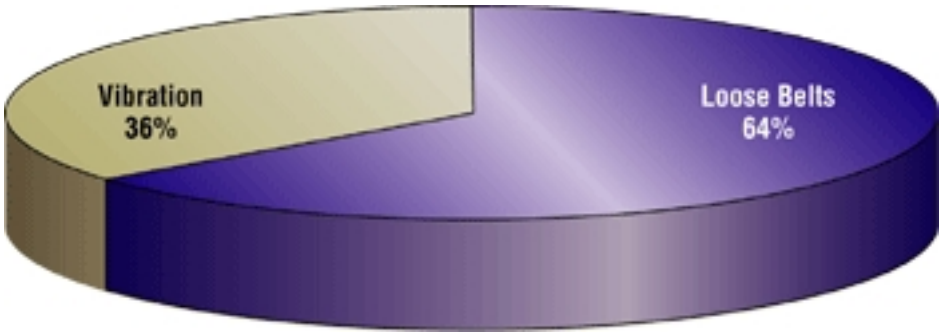
MODEL SZ-3024 WORK REQUEST TRIGGERS

Of the 14 work requests on the model SZ-3024 fans (a centrifugal belt driven fan), 36 percent were triggered by vibration and 64 percent by loose belts (Fig. 3). A study of corrective maintenance work orders revealed that bearings had failed.

The cam-lock style roller element bearings were failing on an average of every 2-3 years compared to their L10 design life of 12-15 years. A thorough review was conducted of the maintenance practices for belt and bearing replacements, the preventive maintenance strategy employed on the fan, and the design of the fan.

Discussions with the bearing manufacturer identified a problem with the site maintenance practice which did not require relocking the collar of the bearing after the run-in of fan belts. Additionally, a more reliable bearing was identified for the application that is expected to improve the overall reliability of the fan. The result of these improvements will reduce fan maintenance at the Harris plant by $21,900.

Fig. 3. Breakdown of fan work request triggers for model SZ-3024.

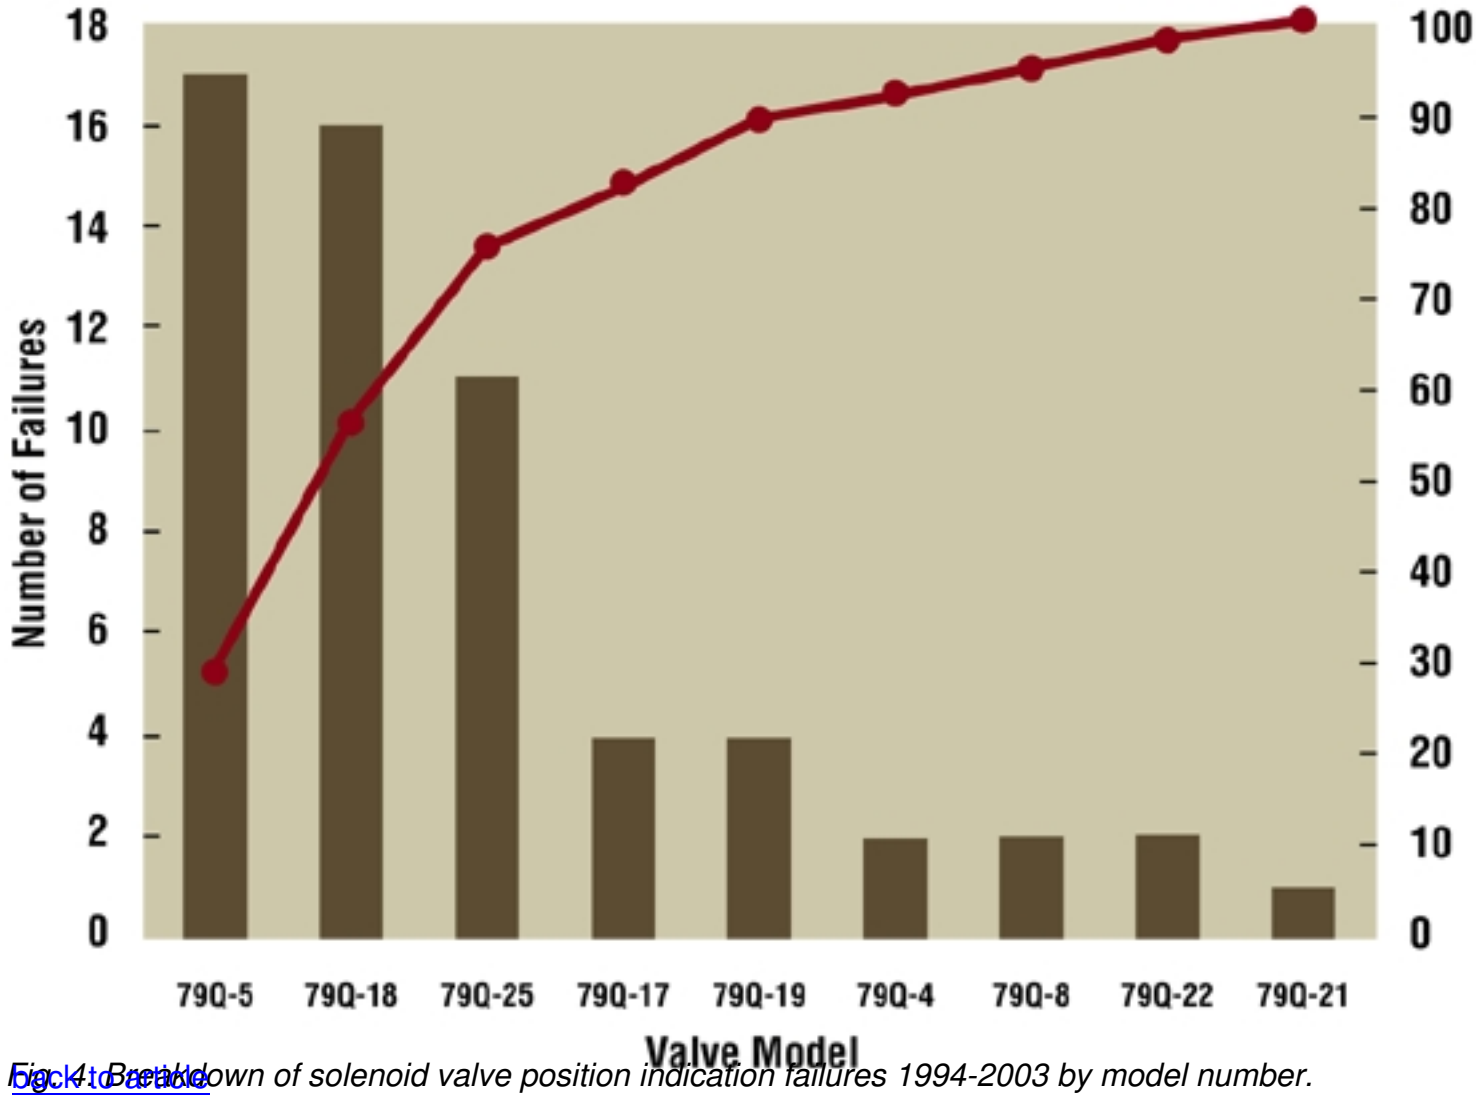
SOLENOID VALVE RELIABILITY 1994-2003

A Pareto analysis (Fig. 4) of position indication failures by valve model number was conducted over a 10-year period from 1994-2003. Three models were responsible for 75 percent of the problems. Recognizing this permitted a focused comparison that identified the same three models had a relay in the position indication electrical circuit. The other models did not have the relay.

Mock-up testing verified the relay was causing excessive voltage spikes across the reed switch contacts that resulted in electrical arcing. Over time, the condition would result in micro-welding the reed-switch contacts together thus producing a malfunction of the position indication. The solution was to install a low cost varistor for voltage suppression that will eliminate the electrical arcing. The expected savings in maintenance is $68,000.

Fig. 4 Breakdown of solenoid valve position indication failures 1994-2003 by model number.
