## When Increasing The PM Period Improves Reliability

Written by Randall Noon, P.E., Cooper Nuclear Station
Wednesday, 01 September 2010 14:06

As this discussion of a power plant's repeated generator-field-breaker failures seems to prove, timing is everything.

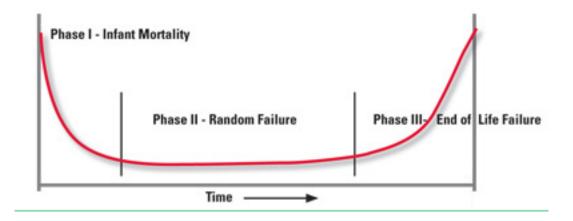
Fig. 1. Failures depicted in a generalized bathtub curve

Phase I, the "Infant Mortality" portion of the curve, reflects the failure rate due to installation errors, assembly errors made at the factory or similar deficiencies. As all the initial problems and "bugs" are found and fixed, the statistical failure rate decreases quickly with time to a minimum level.

Phase II, the "Random Failure" area of the curve, is where the item that has passed through the failures related to assembly error or installation error, operates as designed. Usually this part of the curve is nearly flat and failures are due to statistically random defects and problems.

Phase III, the "End of Life" portion of the curve, is where the item is approaching the end of its useful service life and begins to suffer from wear, age, component breakdowns, environmental degradation and the general curses of entropy.

In depicting the bathtub curve, most textbooks cut the curve off when the Phase III portion is about the same height as the Phase I, "Infant Mortality" portion (as was done below in Fig. 1). Most textbooks also stretch out the time in the Phase I and Phase III portions of the curve, and compress the lapsed time in the Phase II portion. This not only makes the curve appear symmetric (and similar to a bathtub in shape), it makes the curve fit on the page better.

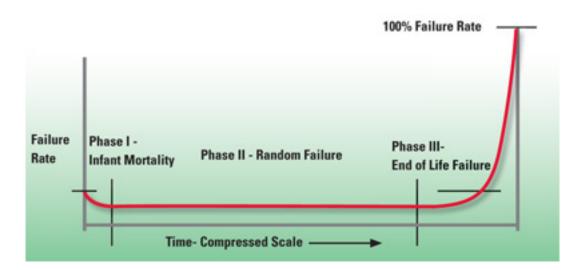
Fig. 2. Failures depicted in a more realistic bathtub curve

A more realistic bathtub curve is shown in Fig. 2. Note that the Phase III portion of the graph is much higher than the Phase I portion. Statistically, if an item is used long enough, its failure rate, given enough time, approaches 100%, while assembly and installation errors are usually an order of magnitude lower than 100%.

Note in Fig. 2 that the high point of the Phase I region is marked with a horizontal line. An equal failure-rate point is similarly marked with a horizontal line in the Phase III region. When an item has been in service for a long time and is in its end-of-life phase, high reliability is maintained if the replacement or refurbishment period is chosen to be equal to or a little more than the peak infant-mortality failure rate. In other words, don't replace an item if the potential for failure due to installation mess-ups or a factory error is greater than just running the item a while longer. Wait until the chance of failure due to service time equals or exceeds the infant-mortality failure rate.

If an item experiences failure due to end-of-life effects and its service life is at the far right on the bathtub curve, shortening the PM period may certainly improve service reliability. As shown in Fig. 2, appropriate shortening of the PM period can shift the PM time from a high failure rate area on the far right to a point on the curve where the failure rate is significantly lower. With some historical data in hand, perhaps the PM can even be shifted to a point where the overall reliability over time is optimized.
