Written by Jane Alexander , Editor-In-Chief Thursday, 01 February 2007 00:00

Reducing Downtime With The Right Balancing Solution - MAINTENANCE TECHNOLOGY

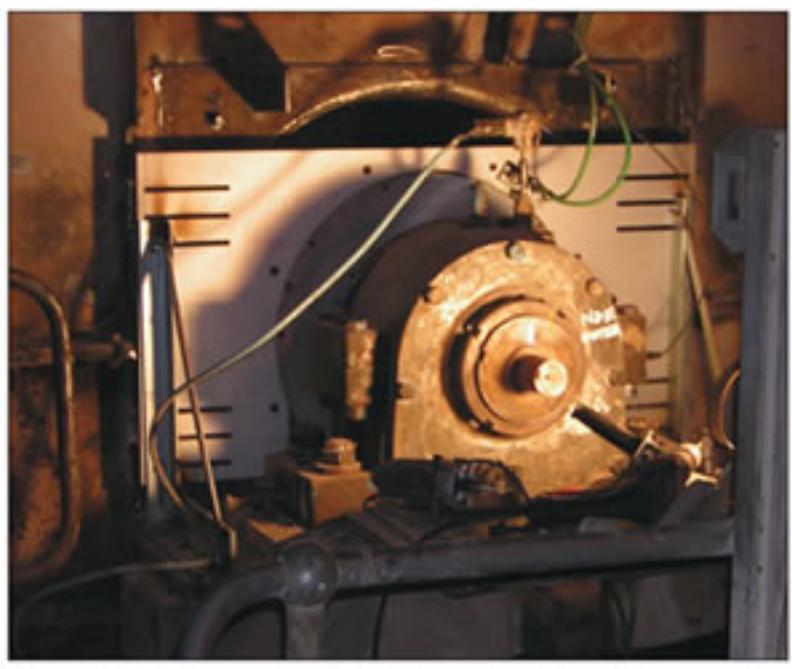
Continual particulate buildup on this kiln pre-heater ID fan rotor (and repeated unscheduled shutdowns to deal with it) impacted Castle Cement's ability to meet production demand. A new balancing system, capable of withstanding the harsh conditions surrounding the unit, now continuously monitors vibration levels and makes rapid corrections while the fan is running.

After analyzing the problem and the fan specifications, the recommendation was to install a permanently-mounted device that continuously monitors fan vibration levels and corrects for unbalance while the fan is running. Although LORD has a variety of vibration control products, this particular type of balancing system was recommended because of its ability to make rapid corrections and withstand the harsh environment surrounding the ID fan.

The system is set up to monitor fan bearing vibration levels and the vibration phase angle in order to automatically correct for unbalanced conditions. This is done while the fan is running at operating speed, eliminating costly downtime to clean and manually balance the unit. Once levels reach a pre-set high trip point, the system switches on, commanding balance mass inside the shaft-mounted system to adjust as needed to counteract the unbalance and reduce the vibration.

The balancing ring of the system mounts directly to the fan shaft and houses counterweight masses that can be repositioned to offset the unbalance detected in the fan rotor. Utilizing vibration sensors, the system monitors the fan bearing vibration. Vibration signals are received

According to Mike Hart, Castle opted to install the balancing system during a regularly scheduled shutdown in February 2006. The two-plane balancing system was installed on the company's #8 Kiln ID Fan (Solyvent Fan), which is part of a 3,000-ton-per-day process. The installation, performed in concert with the TEVA organization, involved moving the motor out of the way, pulling the coupling and bearings off the fan shaft, installation of the balance ring, reassembly of the bearings and coupling and then reinstalling and aligning the motor. Other tasks, such as running conduit and cables between the balancer and the controller and mounting the controller in a dustproof, waterproof box near the fan, were completed in advance of the shutdown.
