## Retrofitting VFDs To Air-Curtain Motors

Written by Joseph C. Pearson and Dilip A. Pandya United States Postal Service New Jersey International & Bulk Mail Center

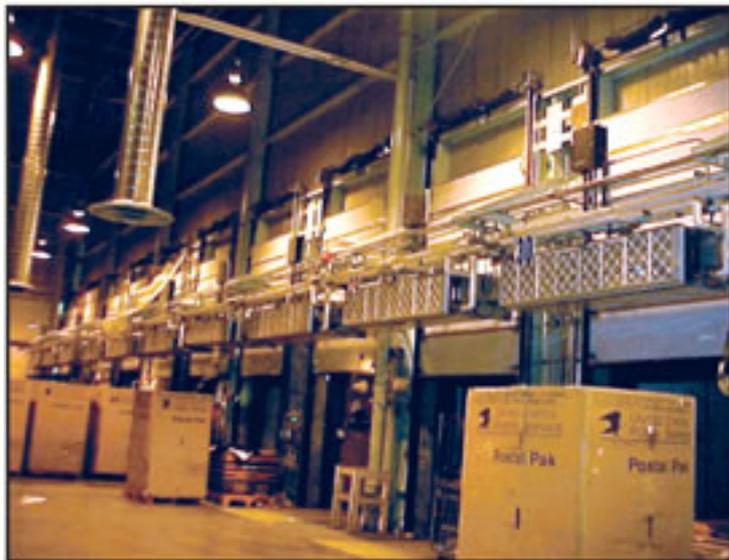
In December 2006 and in January 2007, the NJl&BMC maintenance crew successfully retrofitted and field tested three variable frequency drives (VFDs) on Bays 23, 25 and 26 of the facility (as shown in the accompanying photo.) The units were tested individually and simultaneously to determine if there were any adverse effects on the facility's electrical distribution system and to assess the overall impact of retrofitting 50 more of the site's single-speed aircurtain motors with VFDs. These tests showed that the VFDs were, indeed, very effective-*improving surrounding temperatures (from 65 F to a toasty 77 F), especially when*

NJI&BMC's first air-curtain motor VFD unit was acquired in summer of 2006, without any enclosure or additional harmonic mitigation devices. In-house staff chose to add the choke, wiring, terminal block, fuse holder, etc., and installed the entire unit in a NEMA enclosure at Bay #23. Later, when we conducted an IR survey, we found that we needed additional vent holes to dissipate heat accumulation within the enclosure.

We learned our lessons quickly and procured our next VFD unit with an enclosure and built-in DC choke. Our in-house manpower usage to wire the internal components was not cost-effective, however. Our crew installed this new unit on Bay # 26. We then reviewed our surrounding environment and decided to field-test one more unit without the enclosure or choke on Bay # 25. The vendor loaned this unit, contingent on successful field testing and acceptance. During the installations of all three units, we encountered no major problems-*nor were NJI&BMC's critical 24/7 mail-processing operations impacted in any way.*
